Riley Restorer

**A magazine for Riley restoration enthusiasts in
Australasia Inc March 2025 www.riley-restorer.com**

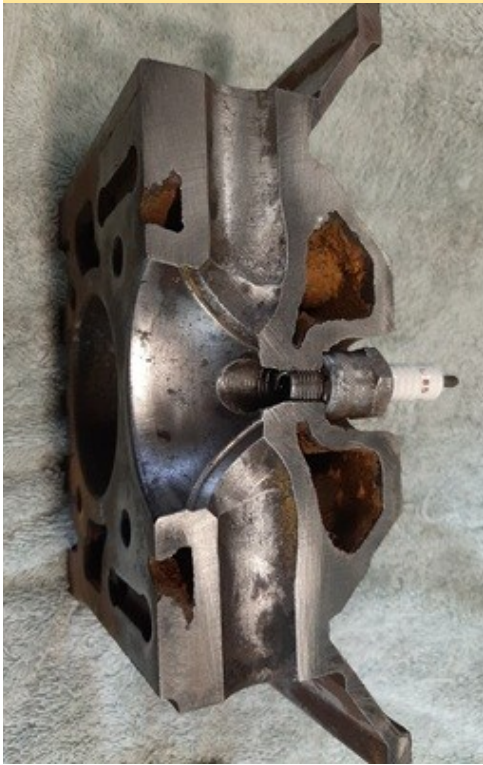
Above: The electrode in this 1/2" reach plug is clearly in the thread well. This is less than ideal for flame propagation.

I am convinced that the information published about the correct sparkplugs for the 12/4 and RMA/E engines is incorrect. It continues to be a mystery why the information has not been corrected. The heads are quite clearly

Personally, I use NGK BP6ES in everything Riley Nine, 12/4 and RMs and have done so for thousands of miles with no issues.

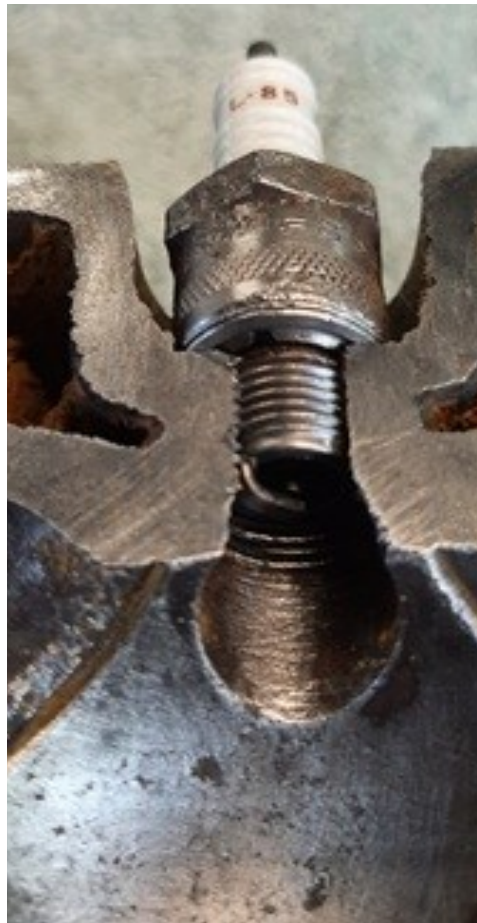
Above: Another view of the 1/2inch plug. You can see that the distance the spark must travel to ignite the fuel is excessive

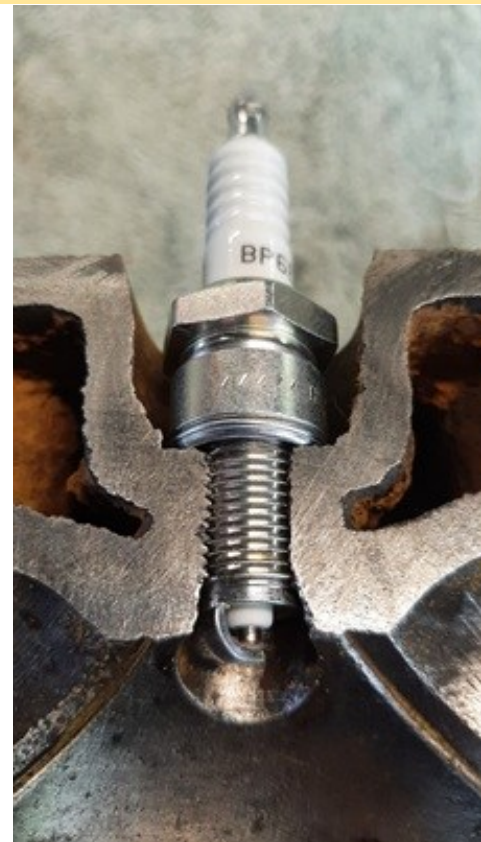
Adjacent: The 3/4 inch plug showing that the electrode does not extend into the combustion chamber to foul with the piston.

The 3/4" plugs with protruding electrode are out in the combustion chamber for better flame front facilitation.

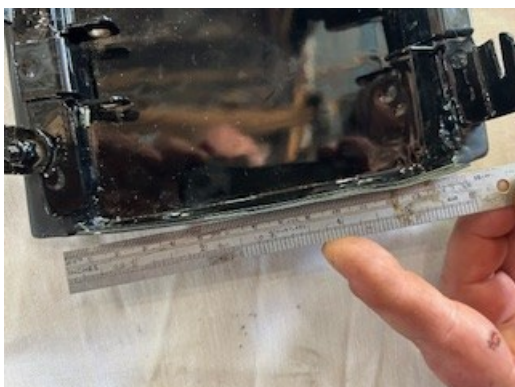
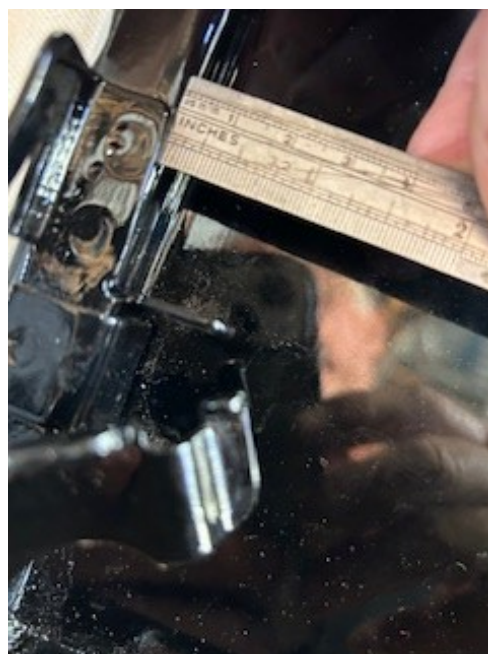
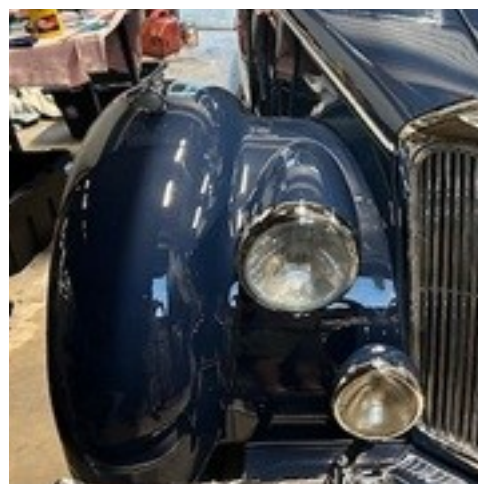
Above top picture: From the factory the bonnet centre was not folded correctly.

Middle picture: Notice the skewed hinge bracket

Bottom picture: Opposite side shows that the spot welder didn't fit the hinge in its correct position.

The interesting part came next. The bonnet hinges and brackets had been twisted with use. On close examination it appeared that the factory worker who spot welded the brackets located them at a slight angle to the one opposite to it and the two opposite brackets were not parallel. That accounted for the twisting of the hinges and hinge brackets. Every time a bonnet side was opened it created stress on the brackets and hinges. Great care was taken by Matthew to straighten the brackets so they were horizontal and parallel with the one opposite to it. The hinges were laid over the template on page S.22.2 of the workshop manual section S and bent to the shape of the pictured hinge. The bonnet sides were fitted in their positions and then adjusted to their best fit up to the windscreen surround and the radiator grill.

The bonnet brackets and hinges were removed for painting. Two of the hinges were bent through many years of use and these were straightened. Quartz halogen light

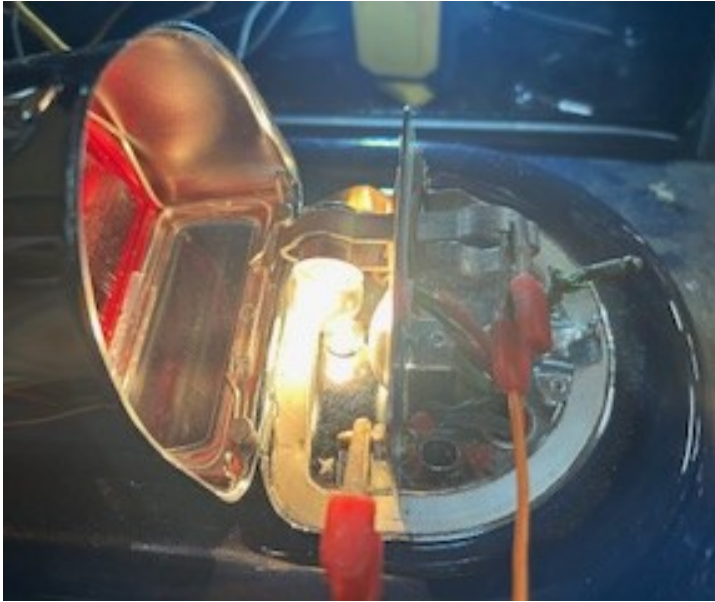
Above: The An earth wire has been introduced to the divider between the stop and tail light

New 'D' lights purchased from England were fitted with very loose hinge pins that were willing to fall out. That was not a big deal.

There was no fitting for an earth so a hole was drilled in the plate that shields the tail light from the brake light. An electrical fitting was soldered to an earth wire

and it was bolted to the shield. It was another easy fix. But later when the circuit was tested neither the tail nor the brake light worked. The wires were checked for conductivity and there was power to the taillight. All the power wires were checked for conductivity and all the earth wires were checked to ensure they were connected to the earth wire from the control box. It was then realised that both the live connections and the earth connections were double isolated from the body of the 'D' light as well as the globe fittings by a

brown plastic and a white gauze material. I conjecture that the manufacture of the 'D' lights was outsourced from England and those who assembled them had no idea about the purpose of the isolating material so both the live wire fittings and the earth wire fittings were double isolated from the globes. The easiest solution was to drill holes into the earth fitting, make a BA thread in them and fit a BA bolt to connect the fittings to the earth fitting with another earth wire. Both the taillight and the brake light then worked.

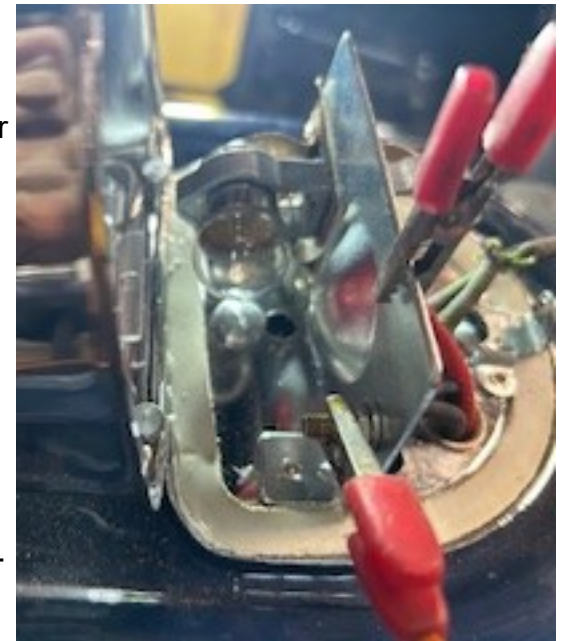
Below: The earth wires was then extended to the glob hold-

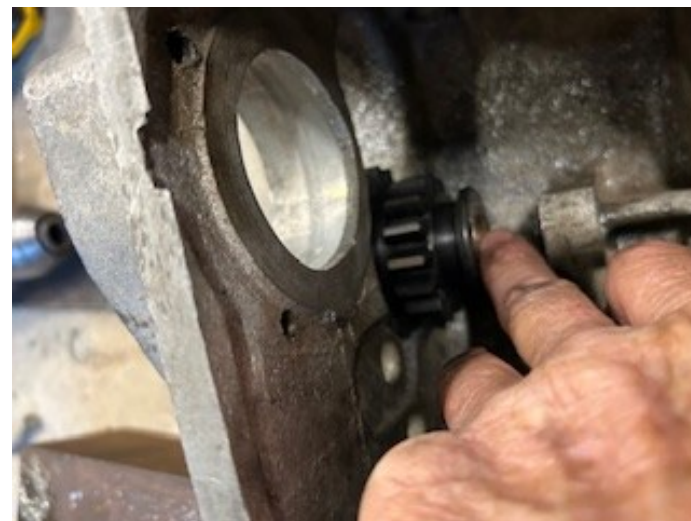
do that, the bush was removed from the gear and another complete bush was machined and fitted. The gear was fitted onto its shaft but the gear did not fit into its cavity in the casing. The OD of the gear was only a few thou bigger than the recess that it was intended to fit into.. After some thought, it was decided to make a shaft with a lathe bit holder to open the cavity for the gear to fit. The size difference was very small, perhaps 2 thou of an inch.

Below: The gear fitted against the cavity that it ought to have fitted into

The original shaft was used as a template for making the cutting tool. The total length of the shaft made is 7 inches long. The end that fits into the housing in the middle of the box is a half inch in diameter and the cut made was 2 ½ inches long. This was to allow the shaft to be moved in and out of the opening in the box and the centre housing to cut the cavity for the reverse gear to recess into it. The drilling for the lathe bit was 15/16ths of an inch from the shoulder of the shaft. The remainder of the shaft was 4 ½ inches long and the diameter was 21/32nds of an inch. The drilling for the lathe bit was at 30 degrees through the shaft and another drilling was made and threaded to fit a grub screw. This was used to secure the lathe bit in its position. At the end a drilling was made through the shaft was for a bolt. A steel tube was made to fit over it and another short shaft was cut to fit into the other end of the tube. Both ends of the tube were drilled to receive a bolt. It made a make-shift universal joint so a drill could be used to machine the box. A full day was required to make the

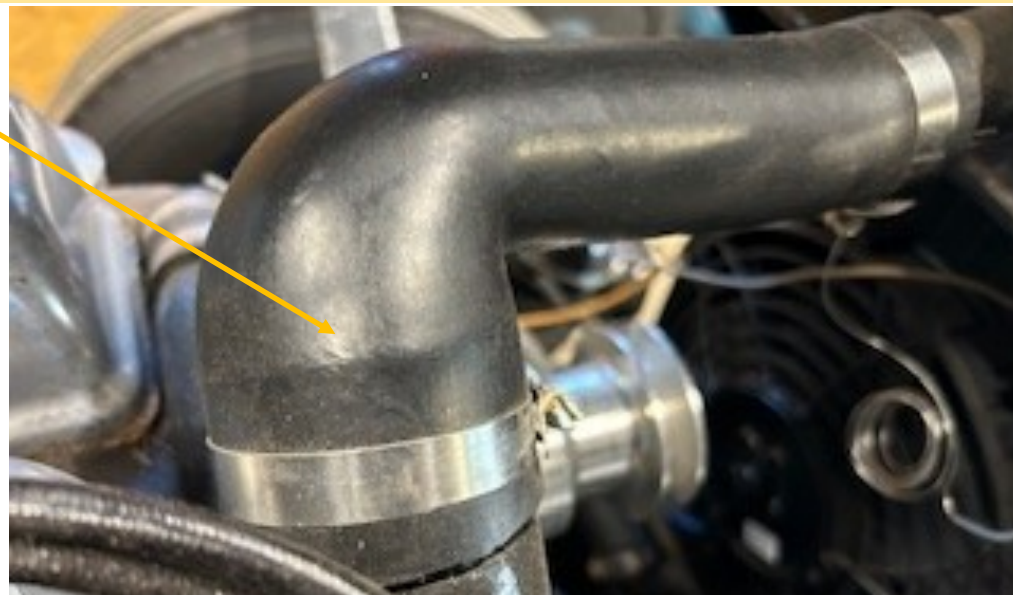
He found cracks in the rubber of the earlier Victorian hose that we had previously noticed and a seam that was beginning to separate. The engineer, Jamie then surprised me. He took a cigarette lighter from his pocket and burnt the end of one of the new Victorian hoses. Immediately the rubber began to smoulder. It produced a particular smell and the burnt rubber disintegrated into black charcoal like particles. Some teaching followed. The smell and the crumbling of the rubber showed that it was nitrile rubber. He explained that nitrile was used extensively for applications that are oily such as bearing and the oil seals. He said that nitrile had an upper temperature tolerance of 90-95 degrees Celsius. Over that temperature this rubber compound will deteriorate and ultimately burst. The temperature in the top radiator hose can rise to 100 degrees C. when the engine is idling in traffic.

Above: An early version of a top radiator hose. Notice the aging and cracking of the rubber

er was because the earlier version disintegrated on a Riley without actually being in use or even having water in the radiator. Jamie brought clarity to this issue by saying that nitrile rubber is ozone and weather resistant poor. He also said that although it has some moderate heat resistance it is less flexible than other rubbers so when a vehicle is in use the movement between the radiator and the

Jamie also said that natural rubber is a far better product for this application than Nitrile rubber. He said that a synthetic EDPM ethylene-propylene-diene monomer could be used to make hoses in automotive applications. Ethylene-propylene copolymers (EP(D)M) are a class of synthetic rubbers produced by copolymerizing ethylene and propylene, and optionally a diene, known as EPDM (ethylene-propylene-diene monomer) or EPM (ethylene-propylene

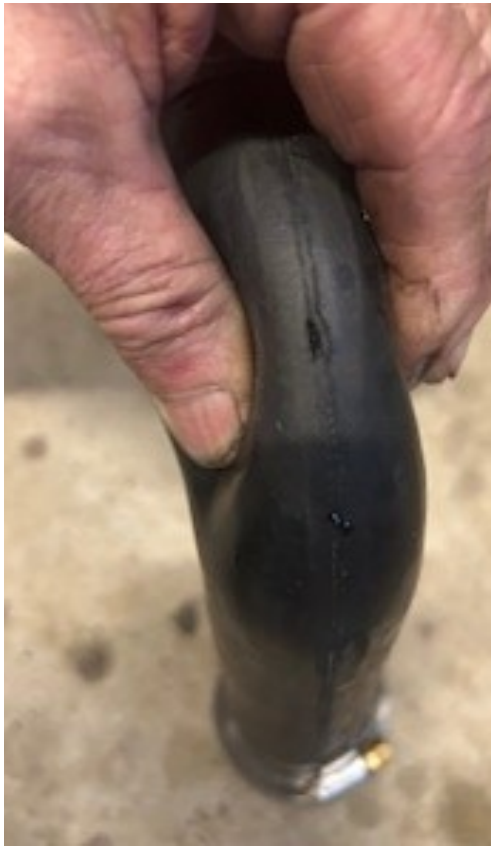
I experimented first on the earlier top radiator hose purchased from VRMC. At 20 PSI the plug popped out so a socket was used to tighten the clamp further. Again the plug popped out and the same outcome occurred three further times. The clamp was tightened even further and at 25 PSI a split began to occur on the outer side

of the bend in the hose and then the plug popped out.

Above: The earlier hose split

The wall thickness was inconsistent on both the earlier and later hoses. The most vulnerable area was clearly the top of the right-angle bend in the hose at that point it was thinner than at any other point. There also appeared to be some indentations and creases on the inside of the bend. Although outside my expertise a better hose would ideally be consistent in thickness. It would be made from natural rubber or EDPM as these materials are not heat or atmosphere sensitive. What is unknown to me is that since the engine moves in relation to the radiator what flexibility is required to give the hose a long life?

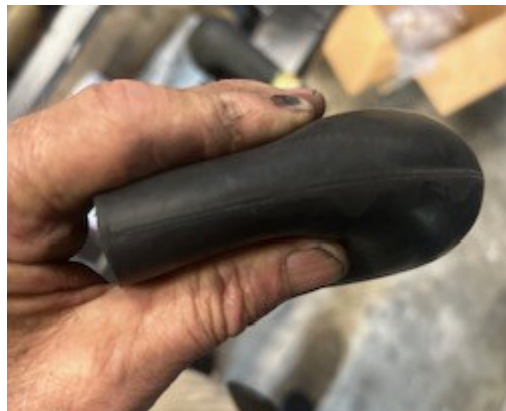
When talking with Jamie previously he said the hose was extruded and in the process the operator of the extrusion machine bent the hose to make the right-angle bend. That is what made the outside bend thinner than at any other point in the hose.

Below: imperfections in the hose are readily seen
