Riley Restorer

A magazine for Riley restoration enthusiasts

in Australia March 2022

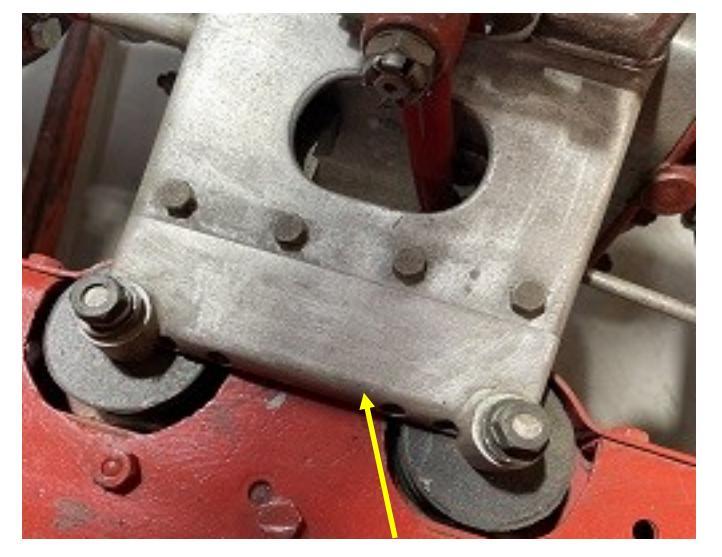
Above: The gearbox addition and mounting

Originally, they were bolted to the chassis as was the engine. There are three fixing bolts that locate the gearbox to the chassis. On his, the gearbox casing was broken on the side where there are two fixing points. On mine they are all broken. His solution is rather brilliant. First, the gearbox casing has been cut along the base (outside of the box itself). He has had another base made and the box and the base are overlapped and bolted together using four bolts on the top and three on the side. The meeting point is almost flawless and a hard act to follow but that will be my first goal.

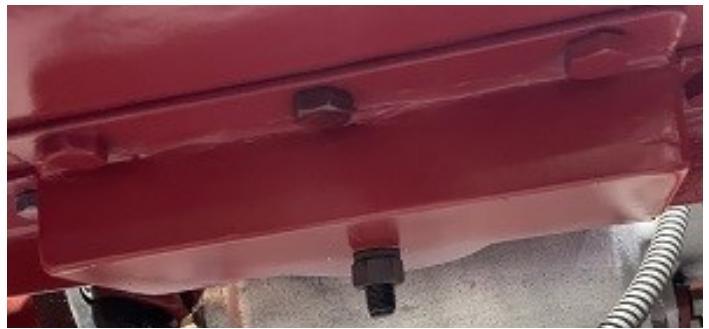
Above: The cradle for the gearbox rubber mounts under the chassis

The fixing point on the other side of my gearbox will require a little more thought as there is a chassis brace that runs from one side of the chassis to the other just below the gearbox mounting. The first option is to relocate the brace but as yet I am unsure.

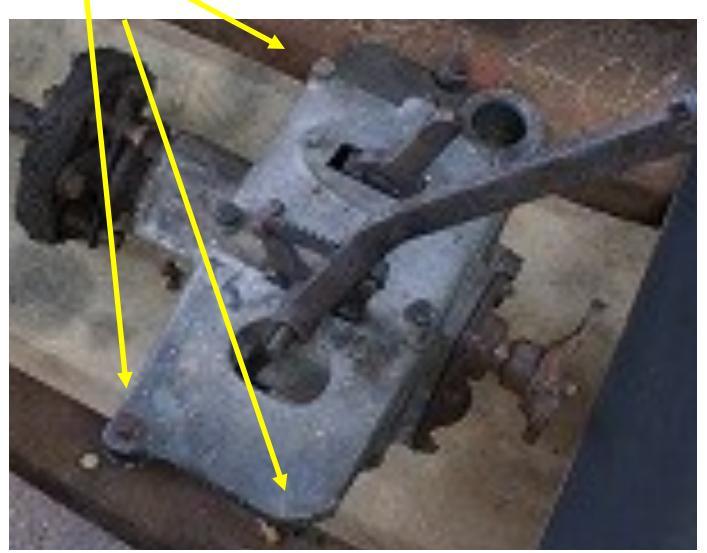
Below: Note the broken fixing points on my gearbox. The one at the front appears to be intact but it is not

At some point prior to his build, Paul Baee mounted his gearbox to a rubber base. Kurt Schultz has done the same and commissioned an engineer to make and fit a cradle as a base for the rubber mounts and drilled 4 fixing points above and 3 fixing points on the side of the cradles to fix them to the chassis. He has fitted these cradles to either side of the chassis. It is a great idea as it secures the box from vibrating against the chassis.

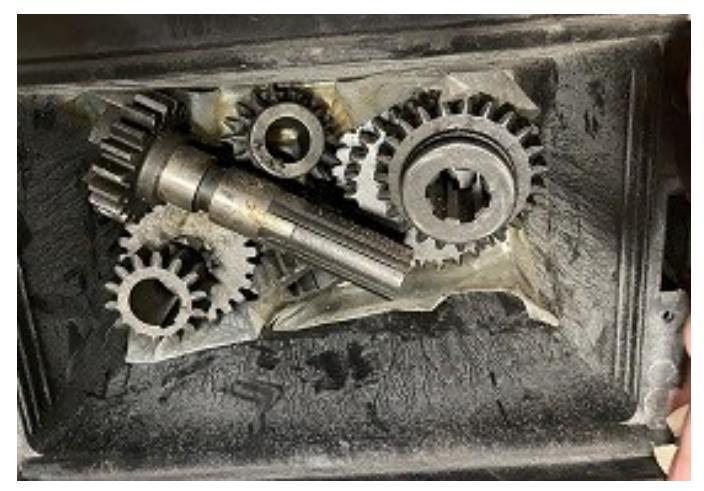
The gear box gears are loose parts in that came to me in a plastic box.

Above: The gearbox components

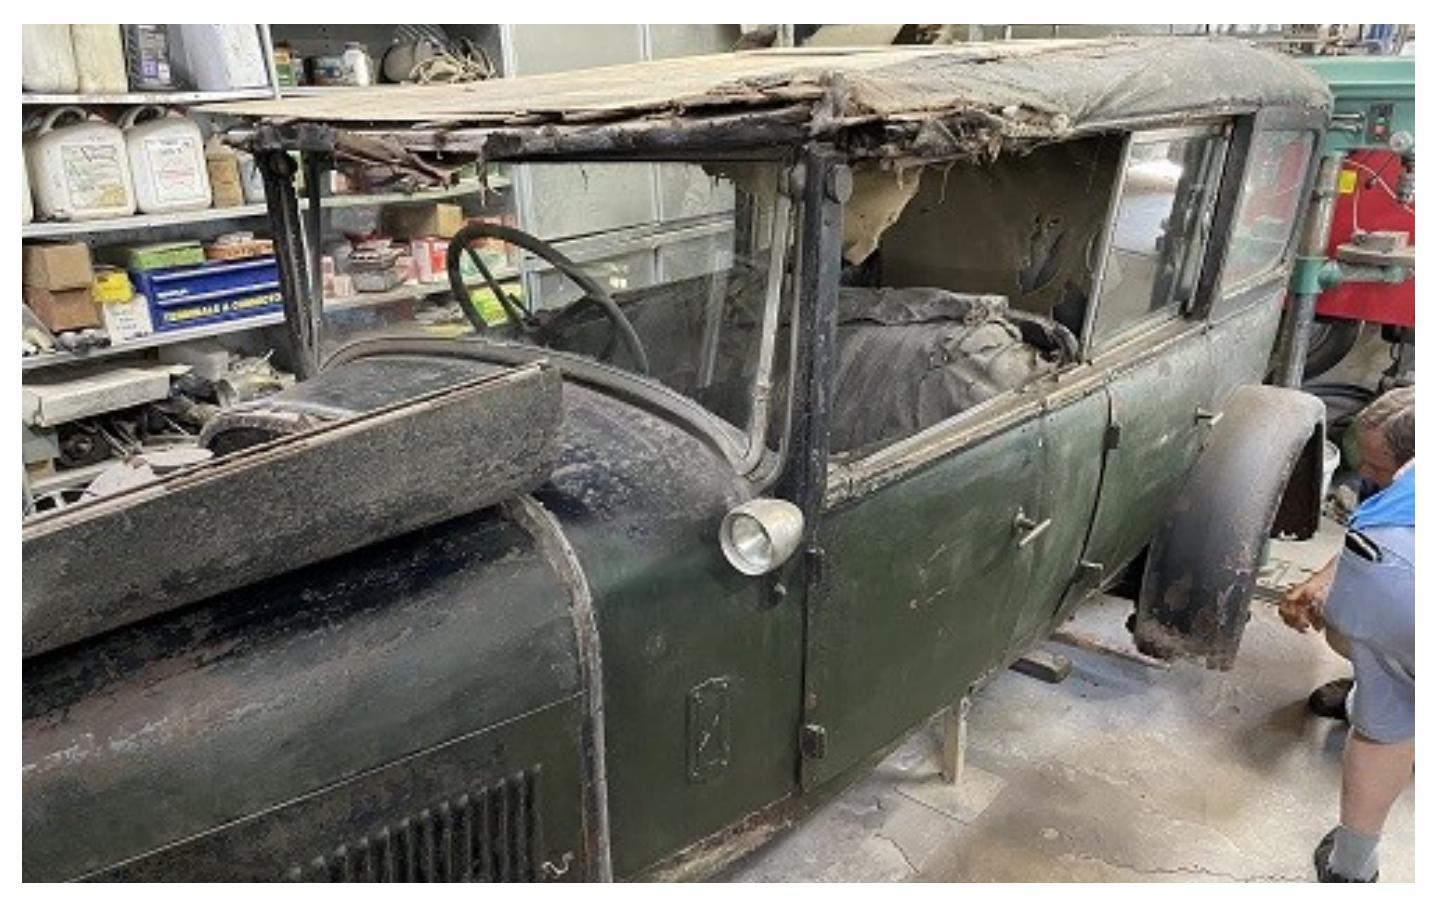
Above: Alan's SV. Notice the sliding glass windows. They slide on runners and come forward in three parts

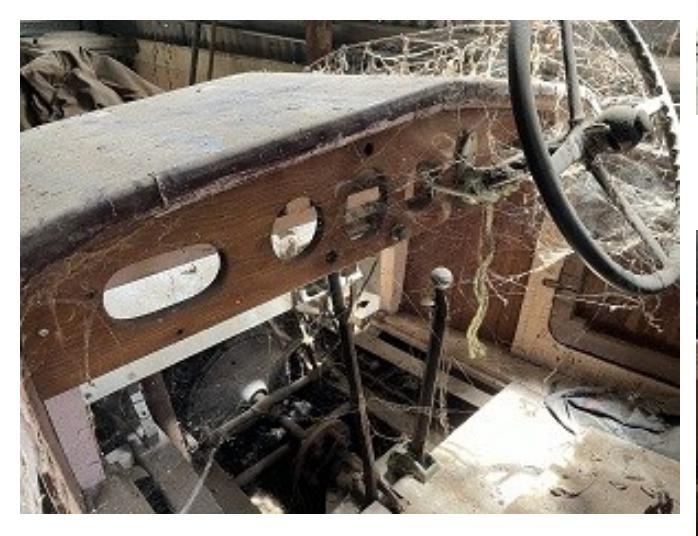
Above: The dash with steering, gearstick and hand brake assembly

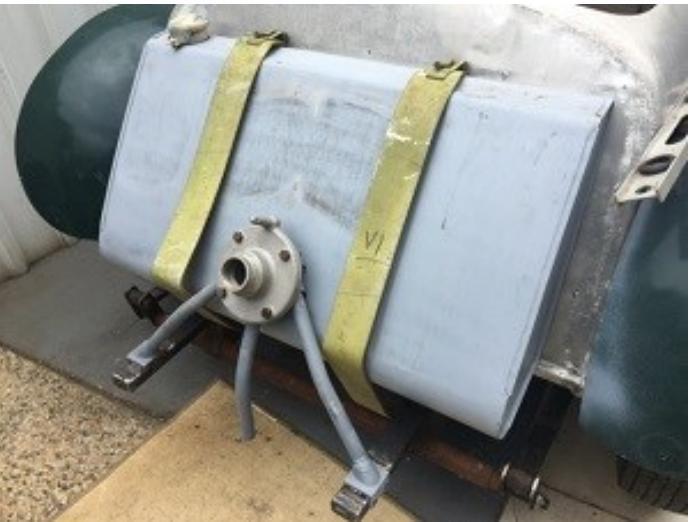
Above: The fuel tank completed and fitted

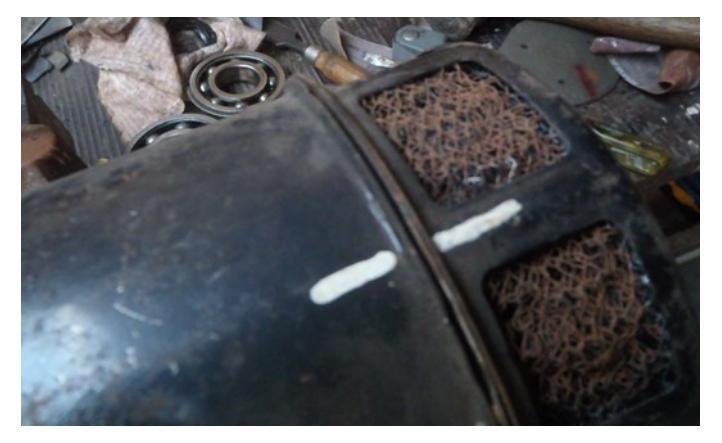
The first step is to carefully grind away the rolled edge that holds the inlet cap onto the main body as shown in the photo. The cap can then be removed along with the course braded wire element and inner retainer. This will expose the inner formed plate which is held in position by three small brazed points that can be carefully cut with a junior hacksaw and split Above: The wire element and the inner rewith a screw driver.

Above: The joint after the grinding operation

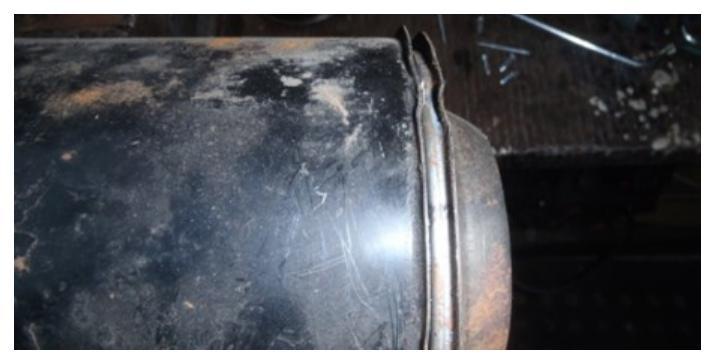
Using a couple of screw drivers gently prise the inner plate away from the main body until you can get your fingers into the gap and then pull the inner plate and inner tube out. The inner tube is held by another plate towards the opposite end with a snug fit on the inner tube. Grind away the outer lip on the inner formed plate equally all round until the plate will enter the main body. Reduce the inner pipe length by 90mm being careful not to deform the pipe.

The joint levered apart with a screw driver

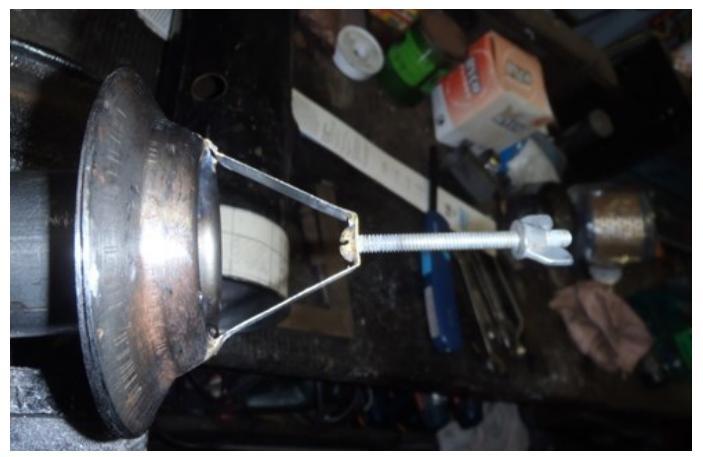
To manufacture the cap clamping arrangement I used a section of purling left over for my shed build with a 3" long 1/4" UNC set screw and wing nut all brazed into position ensuring that the screw is central to the inner plate. What ever you use the critical measurement is to have thread between 85mm and 115mm from the top of the raised part of the inner plate.

Above: Cap fixing arrangement.

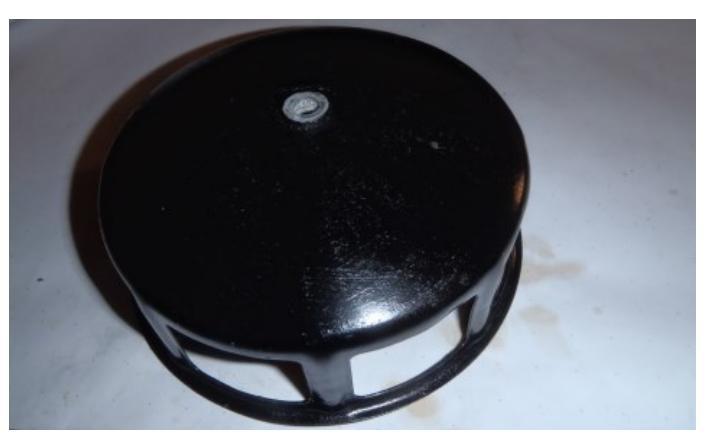
Measure the distance between the base of the thread and the underside of the cap when fitted. Manufacture a spacer or use a nut set at this height to stop any deforming of the cap by over tightening the wing nut. Ensure that all swarf, filings and debris has been removed from inside of the air cleaner before final assembly.

Above: The cap converted and Below: the completed article

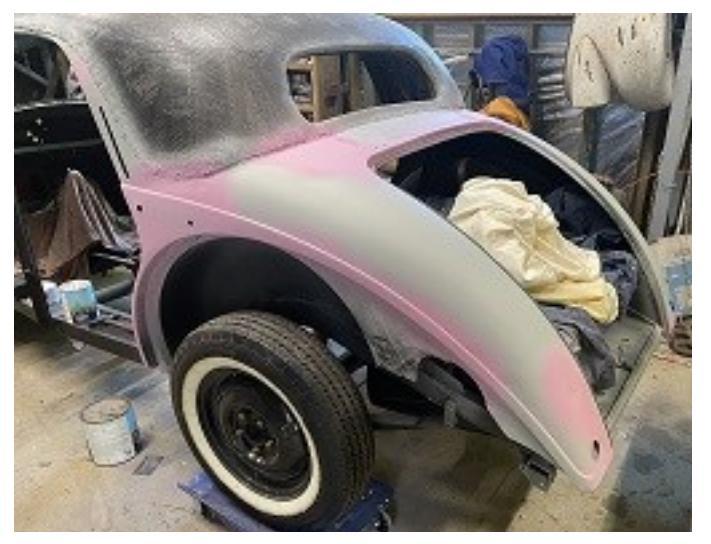
The colour chosen was black. Nuffield would have approved. An etch primer was used to seal the skin. After that a high fill grey undercoat. Then a spray putty was used to fill in all of the small divots around the edges of the body where there was evidence of oxidation and tiny dings. Then the hard work of rubbing it back with a block and 600 grade wet and dry. After that the paint was applied, blocked and painted and blocked until the surface was smooth.

Above: The spots where minor oxidation had eaten the metal surface were filled with pray putty

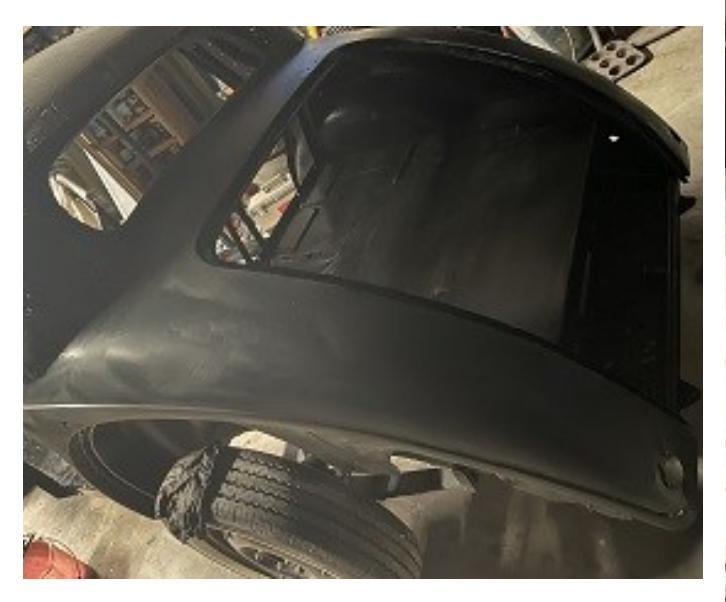
When the colour went on the Riley, the surface appeared straight but when blocked there were some shallow dips where the sand blaster had been a little heavy over the lead wiped areas and numerous tiny divots that needed to be addressed.

Above: The tub appeared to be straight when the top coat was first applied but when blocked shallow spots and tiny divots were revealed.

The solution of course was further painting and blocking until the surface was straight. We are not talking about anything but a few microns but particularly with black paint all the imperfections can be picked out so some effort

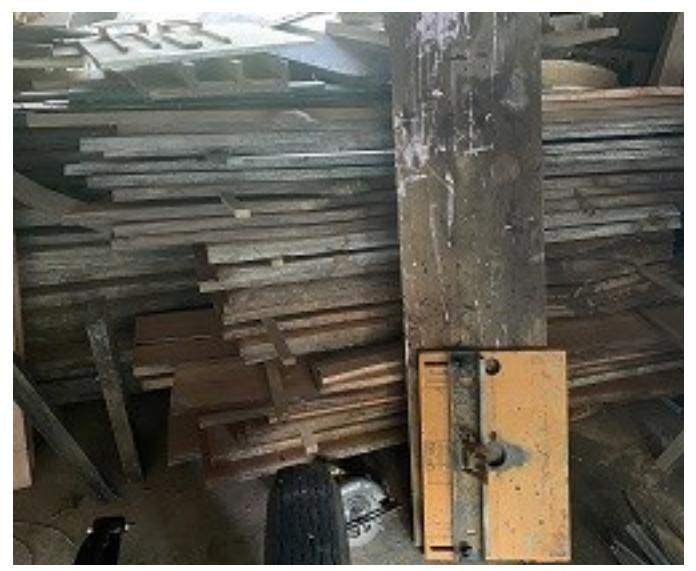
Above; slabs for sills in front and slabs for cant rails and roof rails behind.

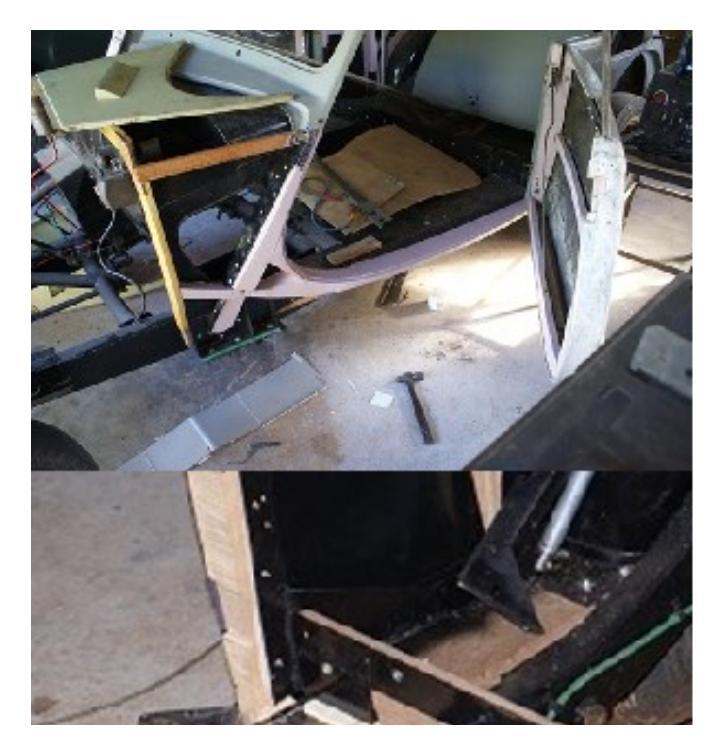
Above: The A pilar is re-enforced with steel

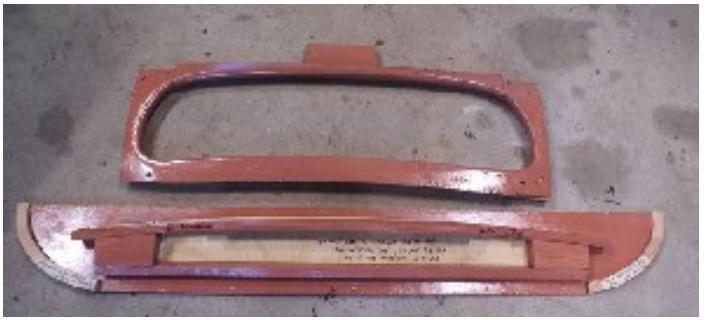
Above: The rear window and fillet assembly with the parcel shelf.

So long as the rear window fits into the cavity with a 1/16 inch gap around the glass, it will fit. The fillet timber is the builder's guide to get the frame central and sitting at the right height. If these are correct then all of the other timbers will fit as well.

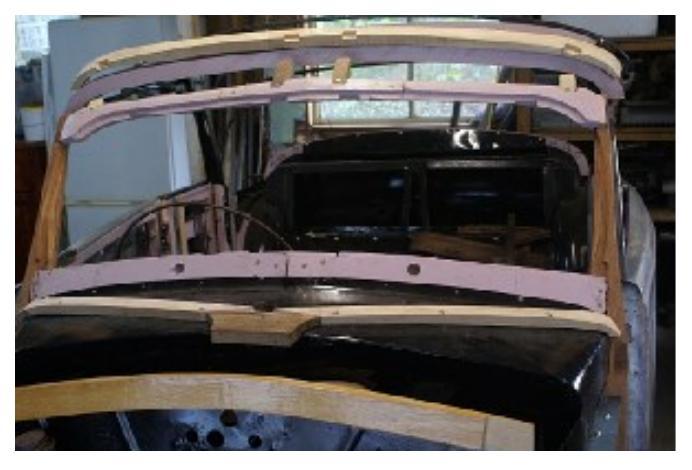
Above: Another view of a top and bottom windscreen rail and the header rail on an RMD.

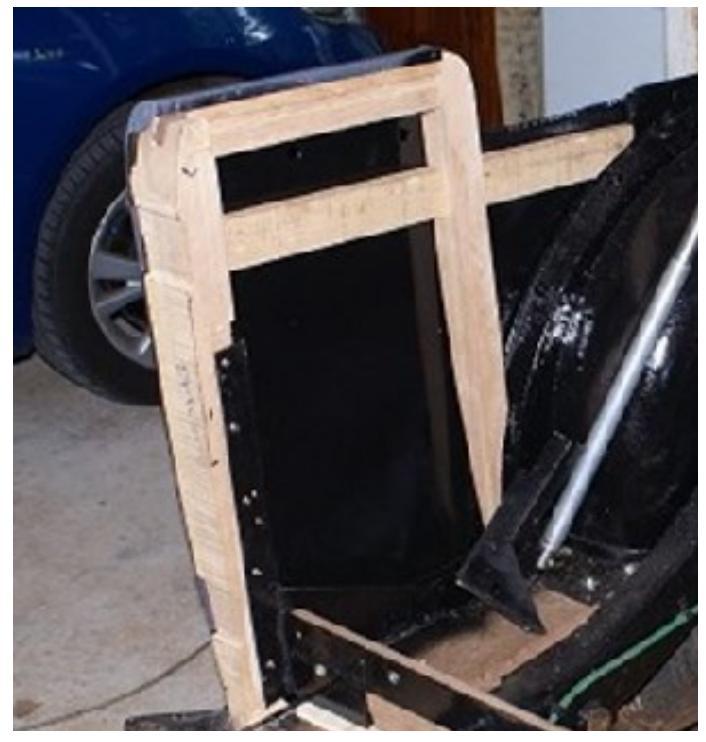
Above: The rear quarter panel in a RMD. You can see the hood assembly piston on Have you noticed, yet that the frames are all the right hand side. The 'B' pillar is reside of the Riley
